# INDIANA DEPARTMENT OF ENVIRONMENTAL MANAGEMENT

January 22, 1997

Re: Gary Development Company Landfill  
RCRA Docket No. RCRA-V-W-86-R-45  
EPA I.D. No. IND 077 005 916

On November 19, 1996, a visit to the above-captioned site was made by myself and Mr. Kirk Maravolo of the Indiana Department of Environmental Management, representatives of U.S. EPA Region V, and Mr. Steve Cherry and Ms. Lisa McKinney from Bose, McKinney & Evans. Enclosed, as previously requested, are two (2) additional photographs that were obtained by Mr. Maravolo during this visit.

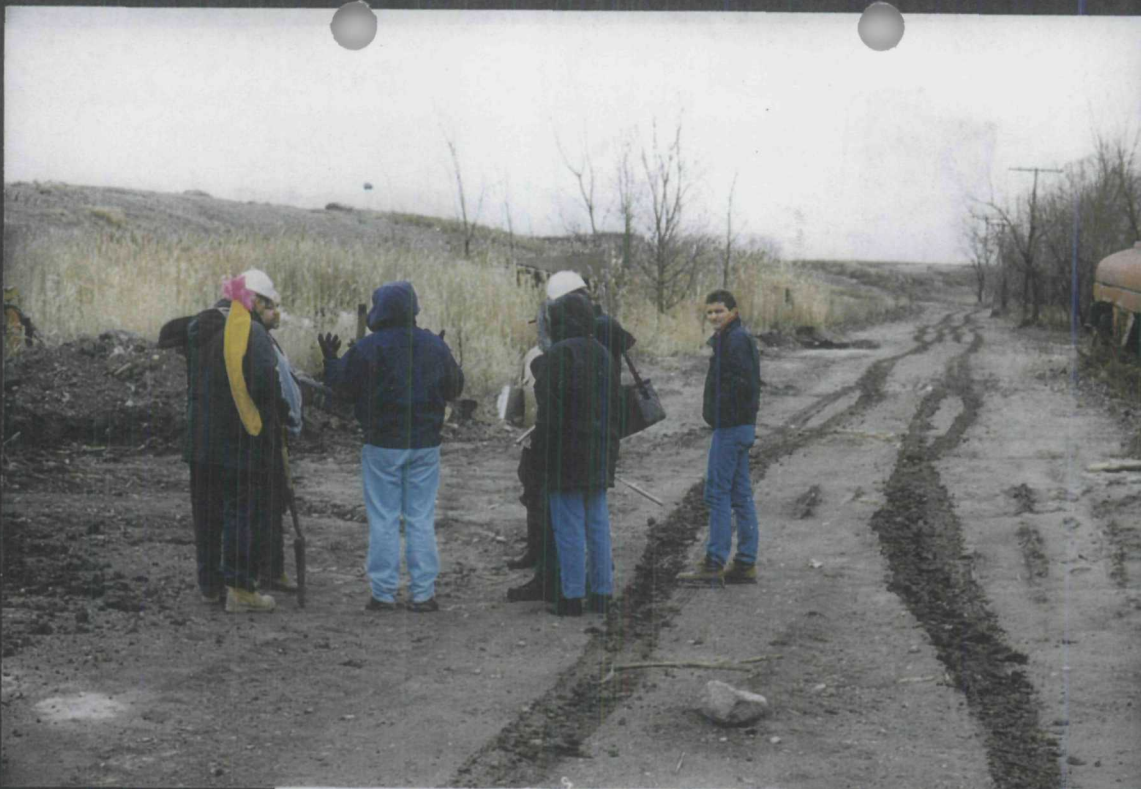
11-19-96 M. Mikulka  
 Gary Development Landfill  
 #3 Inspection team on road at GDC.  
 View from W to E, on S side of  
 LF. Steve Cherry, atty. For GDC  
 facing

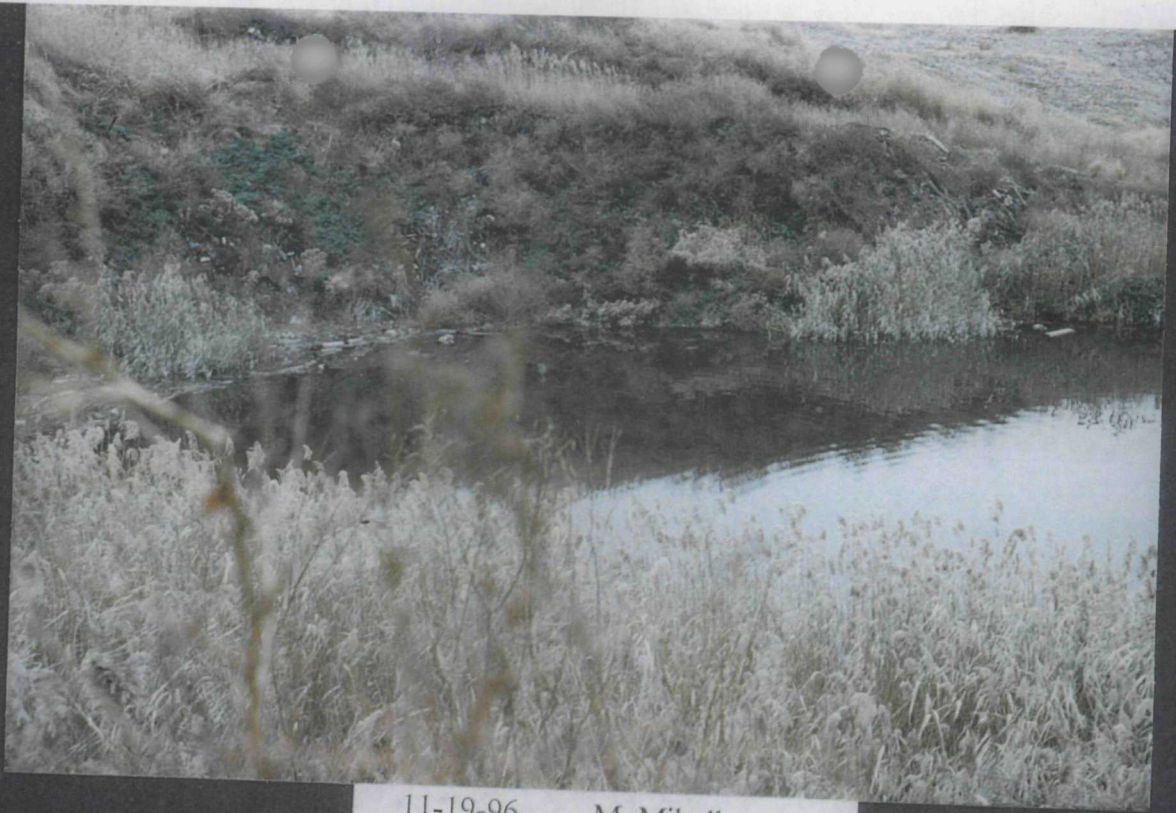
11-19-96 M. Mikulka  
Gary Development Landfill  
#17 -- eastern portion of  
leachate/storm water collection  
pond on north side of Property, as  
viewed from north property  
boundary.

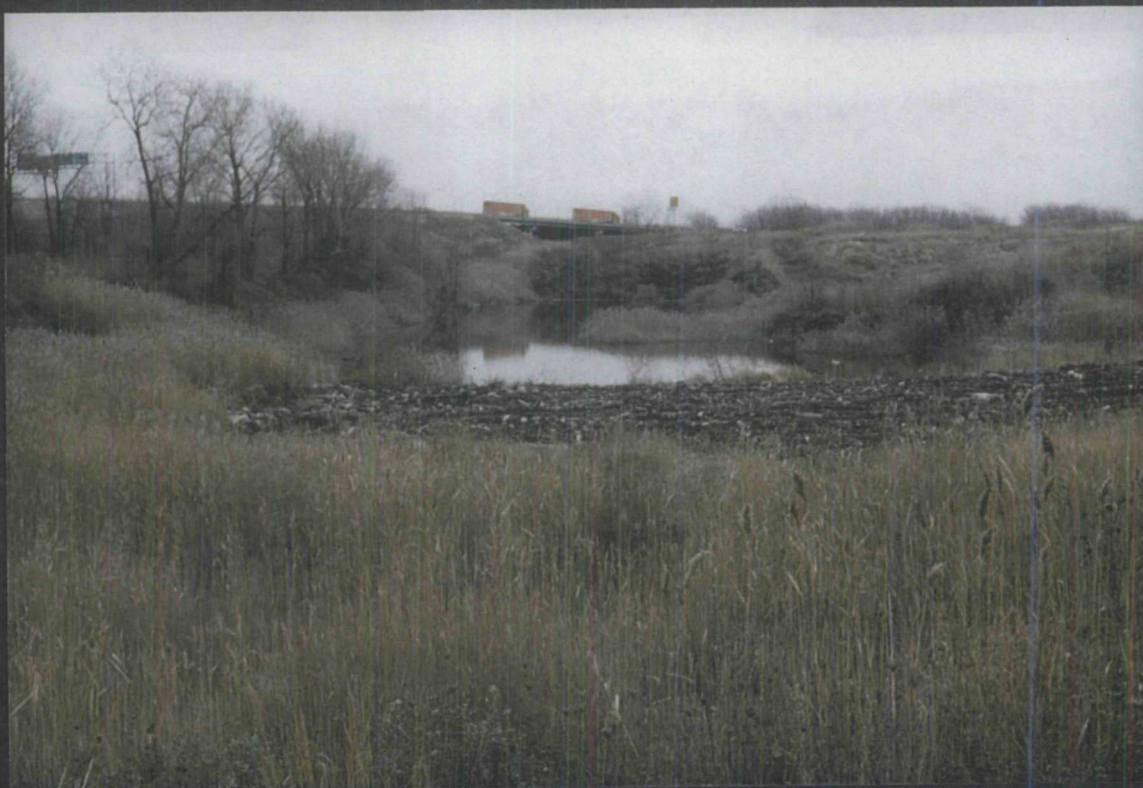
11-19-96 M. Mikulka  
Gary Development Landfill  
#20 -- View of leachate/storm  
water collection pond on N. Side

of GDC Property, as viewed west  
to east. Note Tollway exit ramp in  
background.

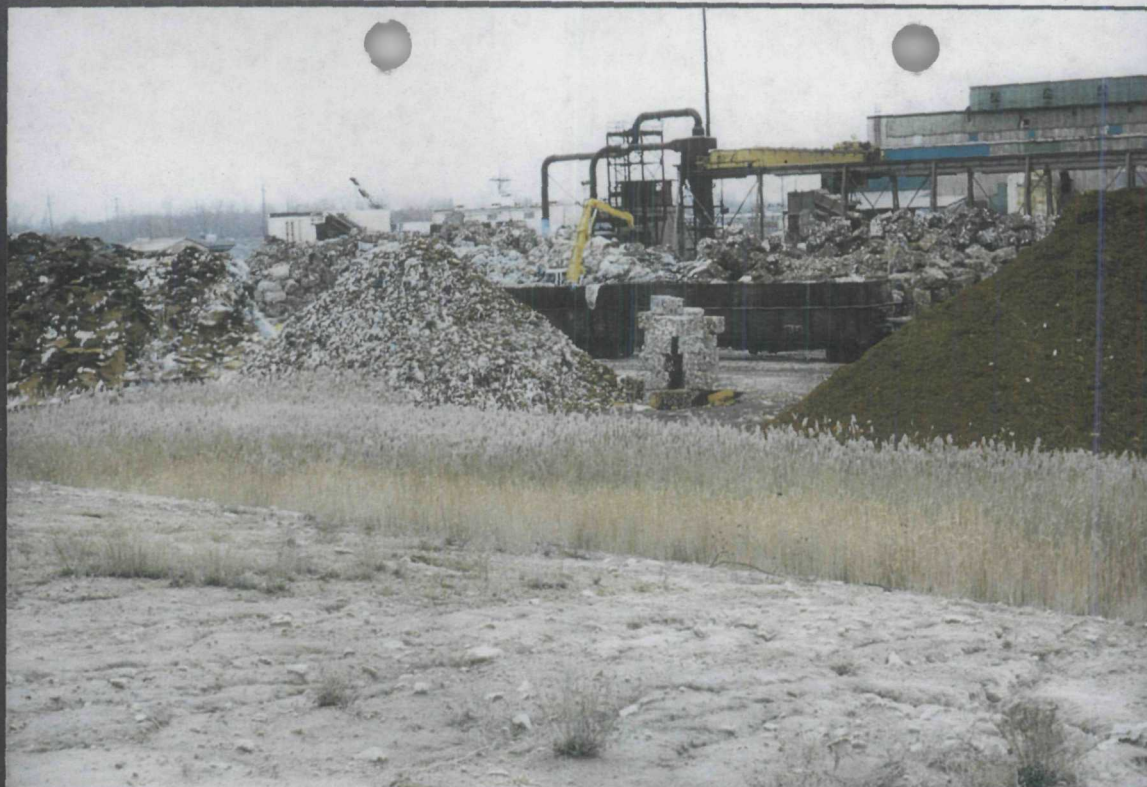
11-19-96 M. Mikulka  
Gary Development Landfill  
#23 -- another view of AMG

Resources facility, 459 N. Cline  
Avenue, Gary, IN 46406;  
ID# IND 005 444 732.
